## Connecting the Revolution of Oeillets slum to the Nantes Métropole sewerage network

30 March 2022

Solidarités International

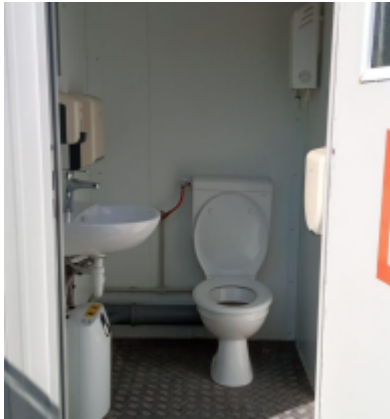
In 2021, two toilet blocks were installed by the NGO Solidarités International. These sanitary blocks are equipped with flush toilets.

In partnership with the metropolis of Nantes, these toilet blocks have been connected to the public sewage network so that the waste water is transported and treated in a treatment station.

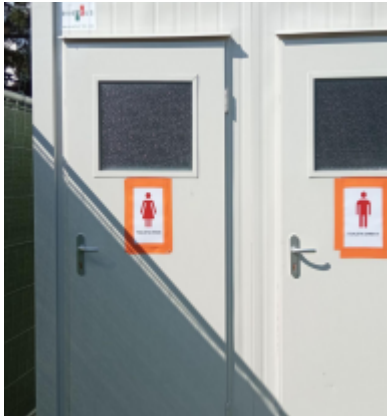
The toilet blocks were installed by the NGO Solidarités International, which rents them to a private company.

Community mobilization revealed a preference for having one toilet block for women and one for men. In order to ensure secure access to the toilet blocks day and night, lighting has been installed.

Screens have also been installed at the entrance to the blocks in order to improve user privacy and limit the risk of use by people from outside the site.

These sanitary blocks are connected to the electricity network and have hand-washing points and heating.

Since August 2021, these two sanitary blocks have been connected to the Nantes Métropole sanitation network. Wastewater is transported and treated in one of the stations in the metropolis. The connection was carried out by the delegate company of Nantes Métropole. Gray water seeps into the ground.
