## ABR ? Constructed Wetland ?Ponds- Drying beds

### **Organisation that implemented the case study**

Solidarités International

Rakhine  
Sittwe camp,  
Myanmar (Burma)

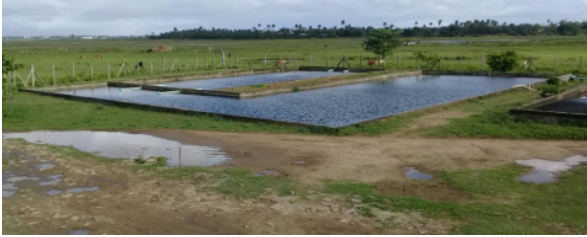
The dumping station is the first module of the Sludge Treatment Site (STS), where the tractors empty the barrel. It is composed of two emptying tanks where the barrel is emptied and its volume measured, with a screen to remove the solid waste, of a channel and of an outlet tank where the scum is trapped.

Two Hopper Bottom Tanks (HBT) are the second module of the STS. It provides mechanical primary treatment which consists mainly of sedimentation and flotation of inorganic material (biological degradation of settled solids occurs partly).

The Anaerobic Baffled Reactor (ABR) is the first module of the STS wastewater treatment line. It provides biological secondary treatment that is the biodegradation of organic material by the micro-organisms contained in the settled sludge.

The horizontal flow constructed wetlands are the second module of the STS wastewater treatment line. It consists of two large gravel and sand-filled basins (that are planted with wetland vegetation). As wastewater flows horizontally through the basin, the filter material filters out particles and microorganisms degrade the organics.

The maturation ponds are the third module of the STS wastewater treatment line. It consists of two large, man-made water bodies in which fecal sludge is treated by natural occurring processes and the influence of solar light, wind, microorganisms and algae.

Infiltration basins are the final module of the wastewater treatment line of the STS. The wastewater infiltrates into the ground through two infiltration basins that are filled alternatively.

The drying beds are the first module of the STS sludge treatment line. They are shallow unplanted filter beds with media consisting of

sand and gravels. The drying process is based on drainage of the liquid through the sand and gravels to the bottom of the bed and evaporation of water from the surface of the sludge to the air.

The secondary constructed wetland is the second module of the sludge treatment line of the STS. It treats the leachate from the sludge drying beds.

The infiltration basins are the third module of the sludge treatment line of the STS. The wastewater infiltrates into the ground through two large basins filled with sand.

The dried sludge storage is the fourth module of the sludge treatment line of the STS. The sludge from the drying beds is stored to further dry.

The incinerator is the fifth module of the sludge treatment line of the STS. The dried sludge is incinerated and the ashes are given to farmers as amendment.

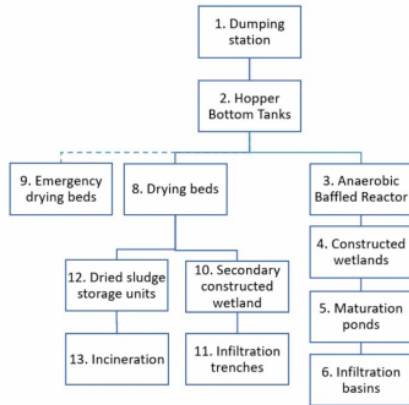
The STS is situated in plains, next to the sea, with rivers running through the landscape and a high water table. In the rainy season, many areas are flooded, but not the treatment plant. The sludge has a strong smell, with no foam and is rather liquid. It contains many worms.

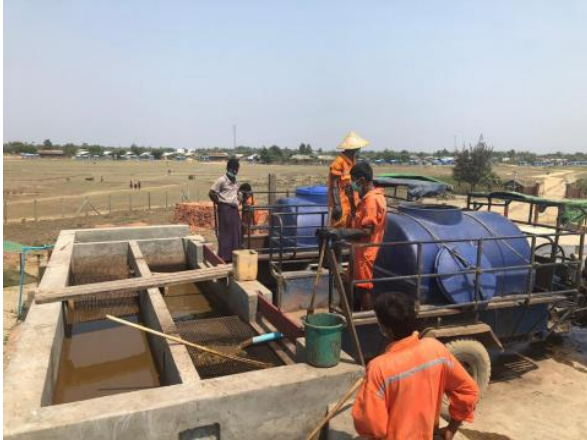
Most modules are constructed with bricks and plaster, and tarpaulin is used when it is necessary to make them watertight. All construction materials are available locally. The hopper bottom tanks are in steel, they were produced in Yangon and assembled in the field. The roofs to protect from the rain and the sun are constructed either in wood or in steel. The brick walls have a lot of cracks due to the bricks and mortar poor quality. They are now five years old and should be rebuilt. Water is needed for construction activities. Access permission and legal authorization are needed for construction and installation. Small constructions, repairs and maintenance are carried out by SI staff or daily workers, while a contractor is used for bigger constructions or services that cannot be done through direct implementation. The initial construction of the plant took about 4 months, and was done at the end of 2013/ beginning of 2014. The land where the treatment plant is located, was identified in partnership with the local authorities in 2013. The land renters were compensated for the loss of agriculture up to 620,000 MMK (half the total amount going to each two land renters). The contract remains active for the complete period of working of the Sludge Treatment Site, and the payment covers the total losses with no further legal or financial obligations from Solidarités International. The total land of the STS is 2.5 acres. Basic skills are needed for the construction. Detailed designs are necessary and a strong oversight from Solidarités International skilled manager on faecal sludge treatment on the construction team needs to be ensured.

The main upgrade implemented was the replacement of the retention tank by Hopper Bottom tanks. It was not possible to desludge the retention tank as often as necessary, so it was replaced by Hopper bottom tanks that are more easily desludged. The overall capacity of the treatment plant needs to be increased. It is currently limited by the unplanted drying beds and the horizontal constructed wetlands capacity. The number of drying beds will be increased and the design of the constructed wetlands will be reviewed. The retention tank was decommissioned. The sludge inside was first emptied with a desludging submersible pump,
