ABR ? Constructed Wetland ?Ponds- Drying beds

Solidarités International

Rakhine
Sittwe camp,
Myanmar (Burma)

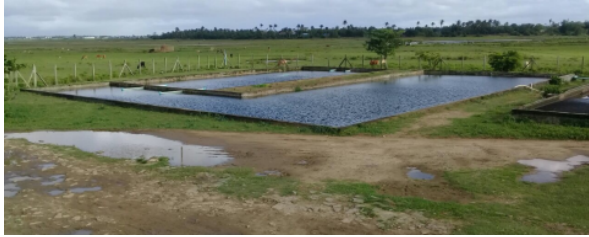
The dumping station is the first module of the Sludge Treatment Site (STS), where the tractors empty the barrel. It is composed of two emptying tanks where the barrel is emptied and its volume measured, with a screen to remove the solid waste, of a channel and of an outlet tank where the scum is trapped.

Two Hopper Bottom Tanks (HBT) are the second module of the STS. It provides mechanical primary treatment which consists mainly of sedimentation and flotation of inorganic material (biological degradation of settled solids occurs partly).

The Anaerobic Baffled Reactor (ABR) is the first module of the STS wastewater treatment line. It provides biological secondary treatment that is the biodegradation of organic material by the micro-organisms contained in the settled sludge.

The horizontal flow constructed wetlands are the second module of the STS wastewater treatment line. It consists of two large gravel and sand-filled basins (that are planted with wetland vegetation). As wastewater flows horizontally through the basin, the filter material filters out particles and microorganisms degrade the organics.

The maturation ponds are the third module of the STS wastewater treatment line. It consists of two large, man-made water bodies in which fecal sludge is treated by natural occurring processes and the influence of solar light, wind, microorganisms and algae.

Infiltration basins are the final module of the wastewater treatment line of the STS. The wastewater infiltrates into the ground through two infiltration basins that are filled alternatively.

The drying beds are the first module of the STS sludge treatment line. They are shallow unplanted filter beds with media consisting of

sand and gravels. The drying process is based on drainage of the liquid through the sand and gravels to the bottom of the bed and evaporation of water from the surface of the sludge to the air.

The secondary constructed wetland is the second module of the sludge treatment line of the STS. It treats the leachate from the sludge drying beds.

The infiltration basins are the third module of the sludge treatment line of the STS. The wastewater infiltrates into the ground through two large basins filled with sand.

The dried sludge storage is the fourth module of the sludge treatment line of the STS. The sludge from the drying beds is stored to further dry.

The incinerator is the fifth module of the sludge treatment line of the STS. The dried sludge is incinerated and the ashes are given to farmers as amendment.
