ABR ? Constructed Wetland ?Ponds- Drying beds

Solidarités International

Rakhine
Sittwe camp,
Myanmar (Burma)

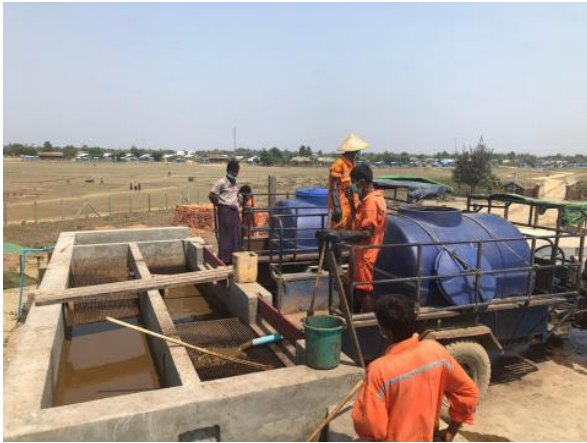
Construction

Most modules are constructed with bricks and plaster, and tarpaulin is used when it is necessary to make them watertight. All construction materials are available locally. The hopper bottom tanks are in steel, they were produced in Yangon and assembled in the field. The roofs to protect from the rain and the sun are constructed either in wood or in steel. The brick walls have a lot of cracks due to the bricks and mortar poor quality. They are now five years old and should be rebuilt. Water is needed for construction activities. Access permission and legal authorization are needed for construction and installation. Small constructions, repairs and maintenance are carried out by SI staff or daily workers, while a contractor is used for bigger constructions or services that cannot be done through direct implementation. The initial construction of the plant took about 4 months, and was done at the end of 2013/ beginning of 2014. The land where the treatment plant is located, was identified in partnership with the local authorities in 2013. The land renters were compensated for the loss of agriculture up to 620,000 MMK (half the total amount going to each two land renters). The contract remains active for the complete period of working of the Sludge Treatment Site, and the payment covers the total losses with no further legal or financial obligations from Solidarités International. The total land of the STS is 2.5 acres. Basic skills are needed for the construction. Detailed designs are necessary and a strong oversight from Solidarités International skilled manager on faecal sludge treatment on the construction team needs to be ensured.

The main upgrade implemented was the replacement of the retention tank by Hopper Bottom tanks. It was not possible to desludge the retention tank as often as necessary, so it was replaced by Hopper bottom tanks that are more easily desludged. The overall capacity of the treatment plant needs to be increased. It is currently limited by the unplanted drying beds and the horizontal constructed wetlands capacity. The number of drying beds will be increased and the design of the constructed wetlands will be reviewed. The retention tank was decommissioned. The sludge inside was first emptied with a desludging submersible pump,

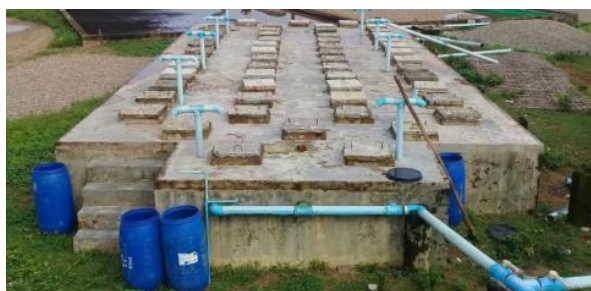
Operation and maintenance

The operation and maintenance activities are included in the operator's manual in annex. Nine non-skilled workers are operating the STS on a daily basis (emptying of the tractors, removing of the dry sludge from the unplanted drying beds, cleaning the STS, etc.). An officer is ensuring the activities follow the standard operating procedures, with basic knowledge of maintenance (see in annex its job description). He is also in charge of operating the laboratory, after following a specific training. An expert technician is necessary to set the proper operation of the plant. Then regular visits need to be planned to ensure that the operation is properly performed and that any issue related to it are solved. Water, brooms, shovels, buckets, spinning wheels, protection equipment, diaphragm pump, sludge judge are necessary for O&M activities. Specific material and equipment to run the laboratory are also necessary. All spare parts are available locally.
